PROBLEM ADVISORY

1. TITLE UT700 LEON3 FT SPARC V8 Microprocessor, 1553 peripheral transmission glitches on power-up sequence			2. DOCUMENT NUMBER SPO-2021-PA-0003									
			3. DATE (Year, Month, Date) 2021, February 1st									
4. MANUFACTURER NAME AND ADDRESS CAES 4350 CENTENNIAL BOULEVARD COLORADO SPRINGS, COLORADO 80907-3486			5. MANUFACTURER POINT OF CONTACT NAME info-hirel@cobhamaes.com									
			6. MANUFACTURER POINT OF CONTACT TELEPHONE (719) 594-8000									
			7. MANUFACTURER POINT OF CONTACT EMAIL info-hirel@cobhamaes.com									
8. CAGE CODE 65342	9. LDC START All	10. LDC END All	11. PRODUCT IDENTIFICATION CODE See table below	12. BASE PART See table below								
13. BLANK			14. SMD NUMBER See table below	15. DEVICE TYPE DESIGNATOR 01								
			16. RHA LEVELS R	17. QML LEVEL See table below								
			18. NON QML LEVEL N/A	19. GIDEP NUMBER GB4-P-21-03								
20. PROBLEM DESCRIPTION / DISCUSSION / EFFECT This document describes a corner case that affects all versions of the UT700 LEON 3FT SPARC V8 Microprocessor. (see appended).												
<table border="1"> <thead> <tr> <th>Base part number</th> <th>PIC</th> <th>SMD number</th> <th>QML Level</th> </tr> </thea

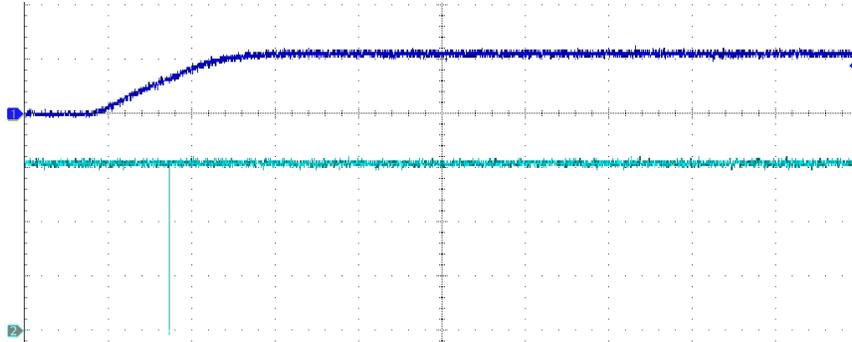
When the LEON processor is powering up with a minimum core voltage setting, its embedded 1553 module transmission signals might glitch (see Figure 1).

Figure 1: The figure shows the core voltage (blue color) during the powering up sequence and a glitch on the 1553 transmission signal (cyan color).

This anomaly will not affect the functionality of the 1553 module, but the transmission signal glitches might interrupt an active 1553 network operation.

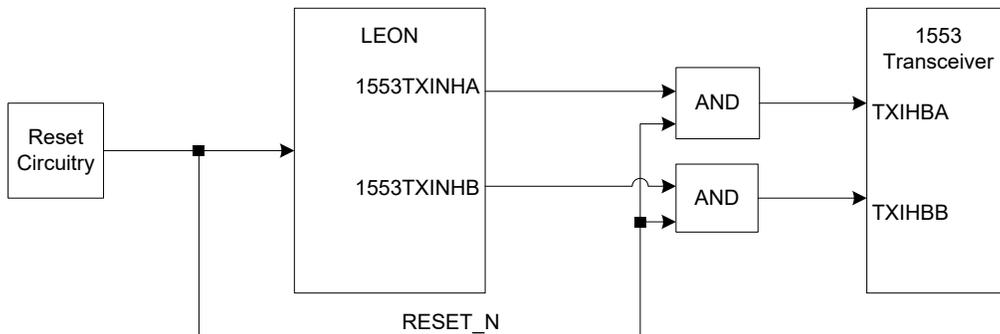
Figure 2: This workaround prevents power up sequence glitches from getting out to the 1553 network

A simple circuitry can mitigate this anomaly by using the external reset signal to gate the 1553TXINHA and 1553TXINHB, driving the TXIHA and TXIHB signals on the 1553 transceiver. This configuration (see Figure 2), gating the RESET_N with 1553TXINHA/B, blocks the glitched signals from propagating onto the 1553 bus.
